# Case History:

## X-Shield Roof Restoration System

### Howard Johnson Hotel, Atlanta. Sept. 05

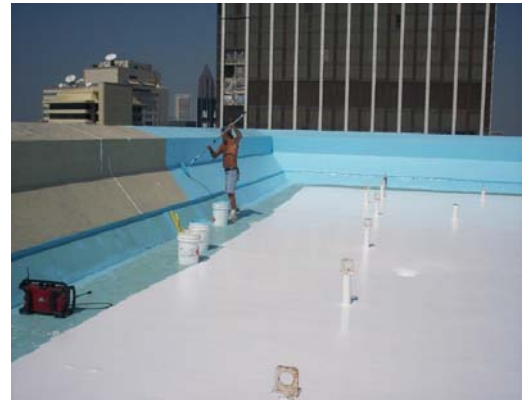
The existing roofing system was a 16 year old 8000 ft<sup>2</sup> EPDM fully adhered membrane roof. Constant maintenance and repairs had been completed over the life span of this system. Numerous leaks into the structure had frustrated the management and prime rental rooms were unable to earn revenue because of water damages, falling drywall and the odd odor of mildew. It was determined that bad flashing details, splitting seams and screws from the mechanical attachment of the 1" ISO insulation were backing out and popping through the EPDM membrane
