## Case History: X-Shield ProFlex One/ProThane Airbus A380 Hangers Dubai International Airport

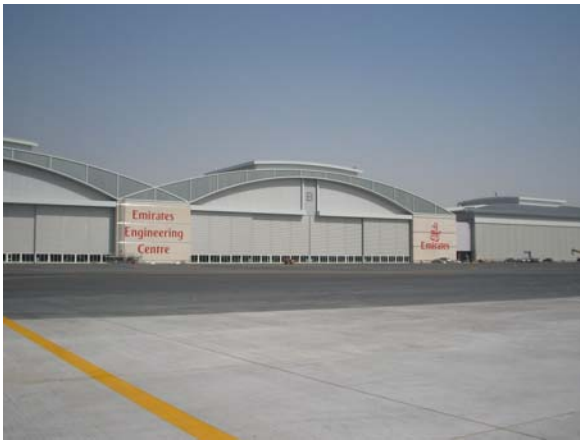
A concealed aluminum gutter system was used on these structures to channel away rain water. The joints were simple overlaps riveted together. Minor leakage through the joint was acceptable as rain in Dubai is infrequent and the gutters would drain the water away quickly. The problem was with dealing with the early morning condensation which created an unforeseen volume of water. The gutter design was not able drain away this amount of water quickly resulting in almost daily leakage of water through the joints.
